State-wide schools' maintenance audit in Victoria, Australia: The framework and process

ARTICLE FOR STRUCTURAL SURVEY

Statewide Schools' Maintenance Audit in Victoria, Australia: The Framework and Process

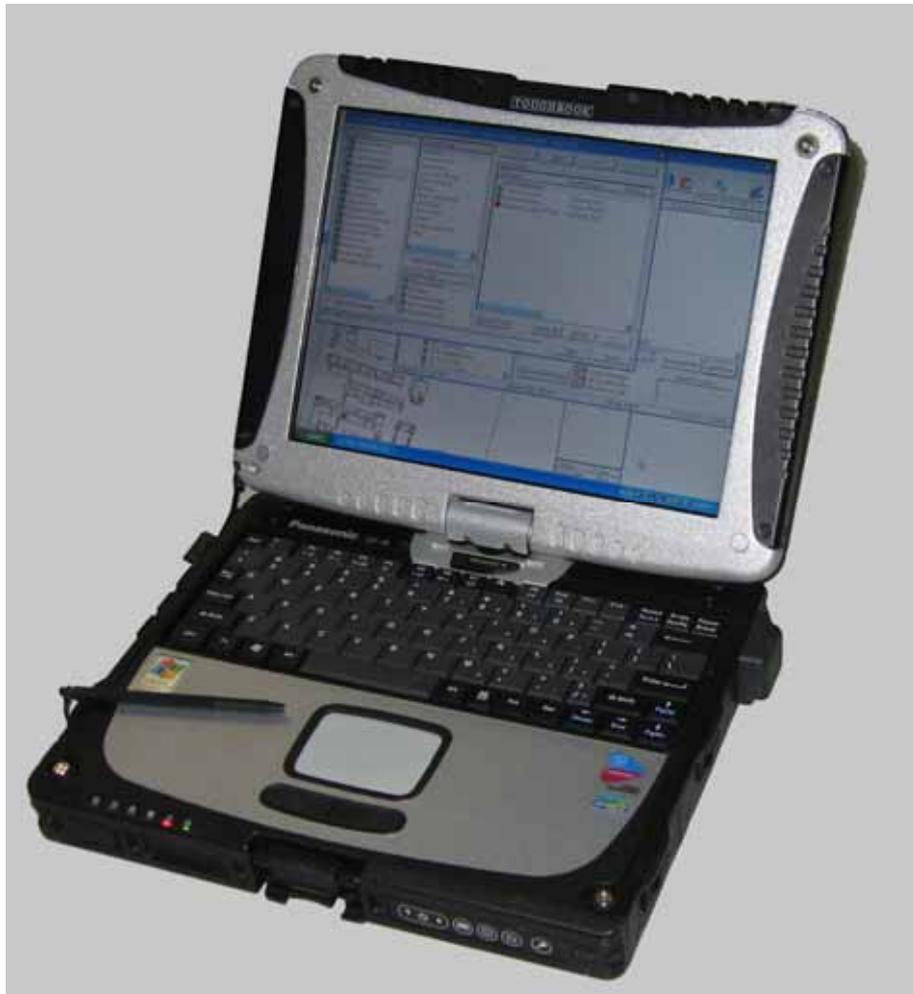
Figure 1 PAC used for the schools audit inspections

The audit is carried out with the assistance and support of a pen-activated computer (PAC). See Figure 1 for details of the equipment. For information this model is the *Panasonic (National) Toughbook CF-18 Standard*.

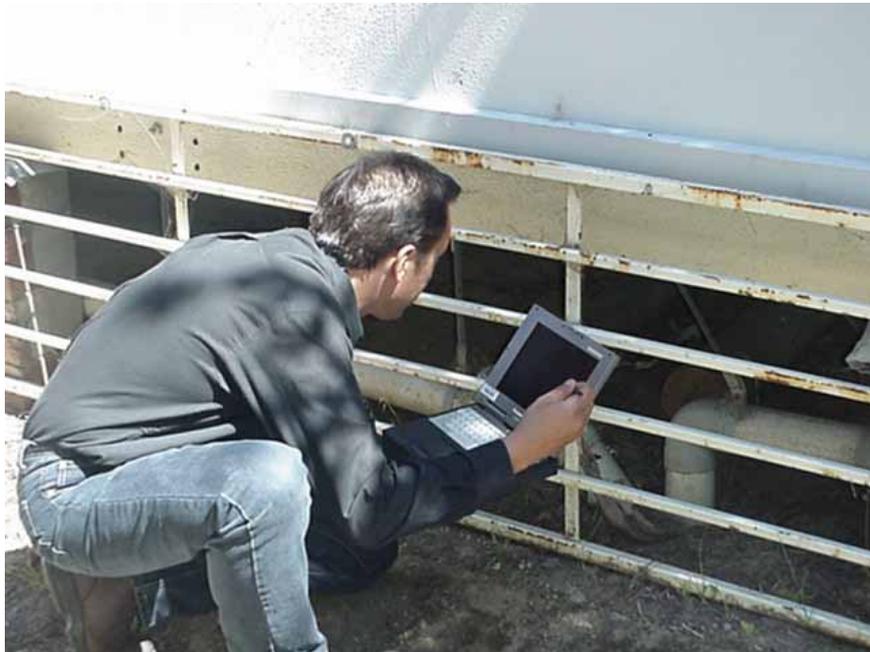
Figure 2 An Inspector using the PAC on site

The use of the PAC in practice by an auditor or inspector is shown in Figure 2.

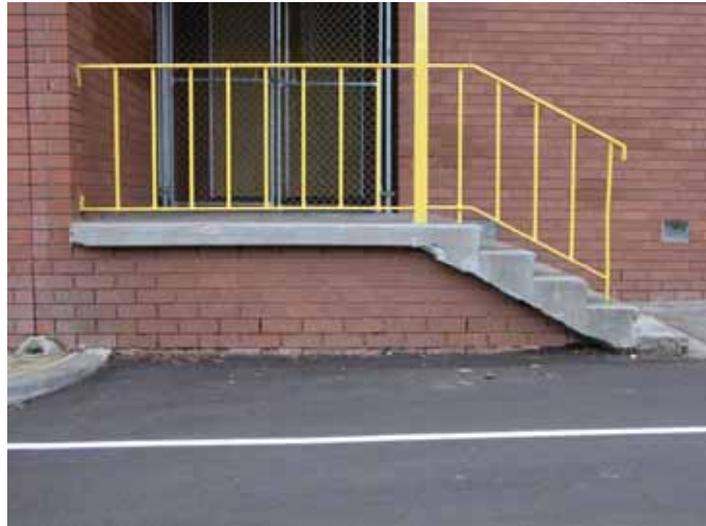
Concrete Steps

No major break-up of surface, nosings, etc.

Stairway is fully functional

Condition = GOOD
Priority = NO
PRIORITY

To illustrate an example of an item or element in GOOD condition (that is, requiring no maintenance) a typical one is shown below for concrete steps. This example is to guide the inspectors in their assessments and is taken from the *Physical Resource Management System (PRMS) Maintenance Assessment Guidelines* (DET, 2005).

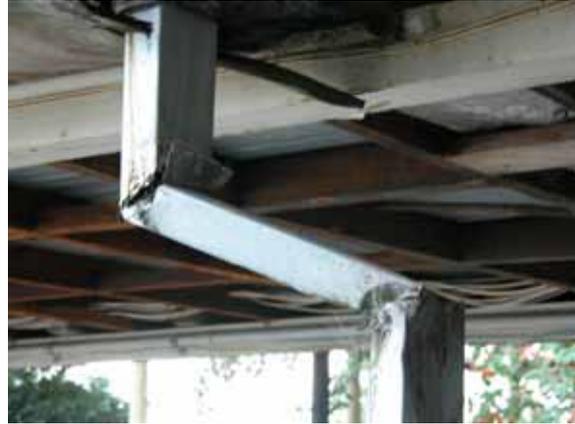
Down pipes

Damaged down pipes not capable of carrying storm water. Leaking on to ground and compromising the use of the area. Potential safety issue. Requires replacement.

Condition = POOR (failed or inoperative; no longer performs its required function).

Priority = A (Risk or safety issues, limit use of space)

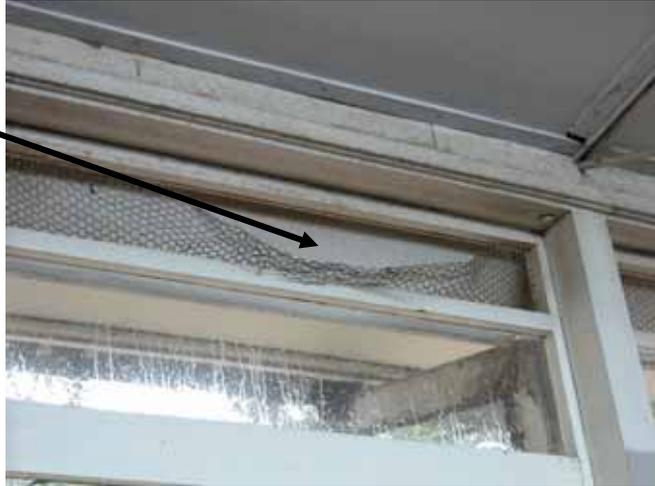
Windows

The fly screen is no longer functioning. This area is not a food preparation area or mosquito problem area where strict standards apply. The condition may cause some minor annoyance to room occupants.

Condition = POOR
Priority = C

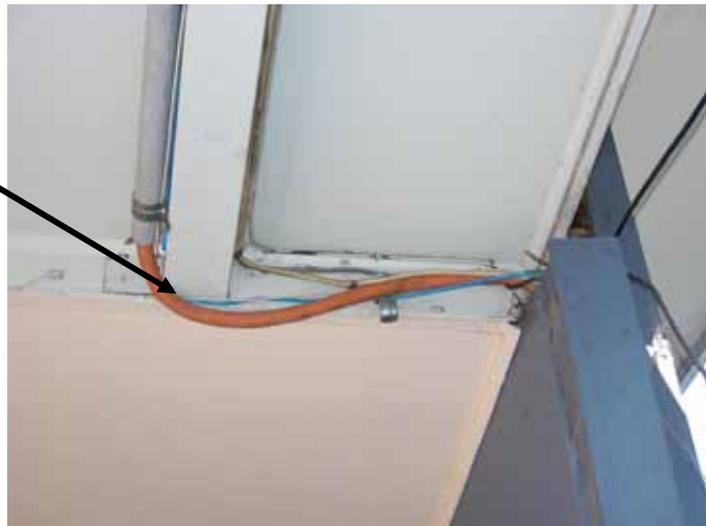
Supply Mains

Exposed mains wiring accessible to students due to poor construction methods. Functionality of area marginally compromised due to height of wiring.

Condition = POOR
Priority = C/D

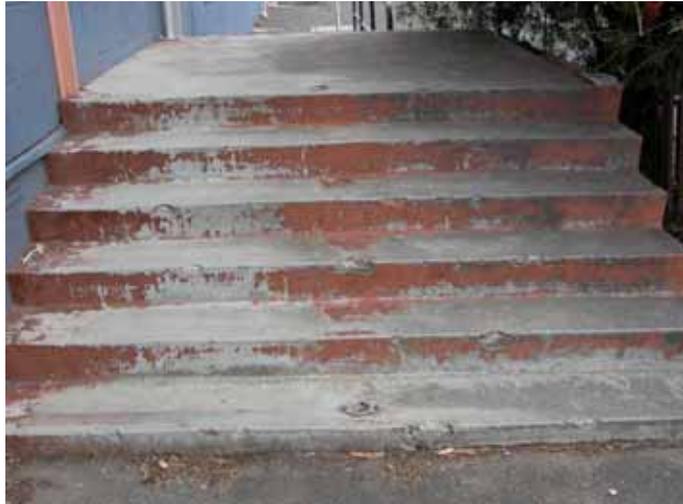
Steps

The stairway is no longer in use, but students still sit on it, etc. Step edges are broken, possibly a minor slipping hazard. The stair is not used in emergency.

Condition = WORN
Priority = D

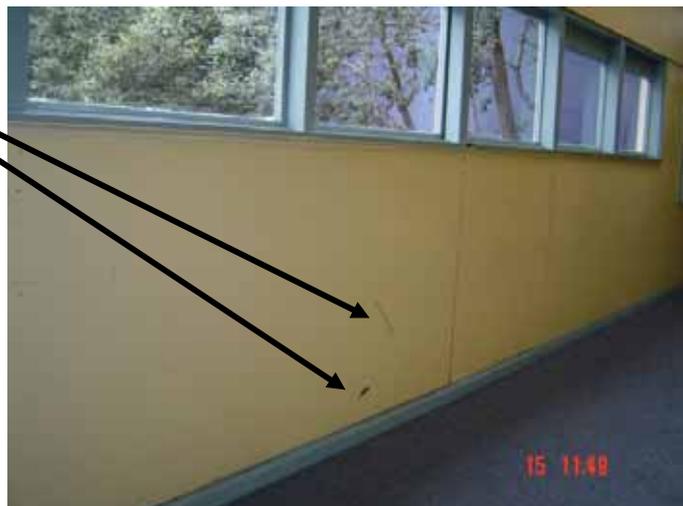
Scuffed Walls

Typical corridor with scuff marks, minor scratches, etc. Functionality not compromised. Repairs are not urgent.

Condition = FAIR
Priority = C/D

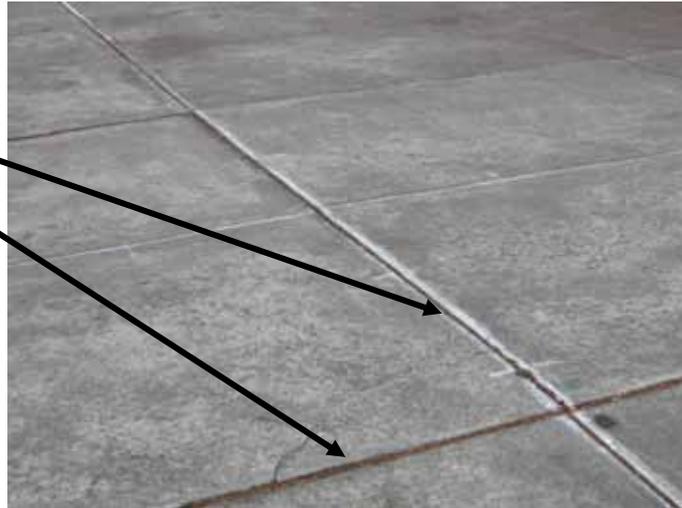
Paved Areas

Minor differential settlement less than 5mm. Minor tripping hazard.

Condition = FAIR

Priority = C

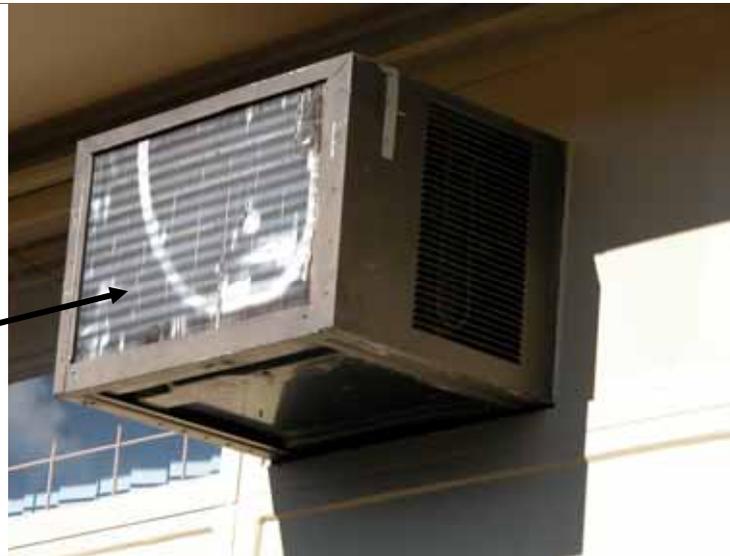
Room Air Conditioner

Check physical condition of the unit for damaged fins, rust and support brackets. Also check externally for damage to fascia, controls, etc and if any damage internally.

In this unit the fins need combing out. Will have a minor effect on the functionality of the room.

Condition = FAIR

Priority = D

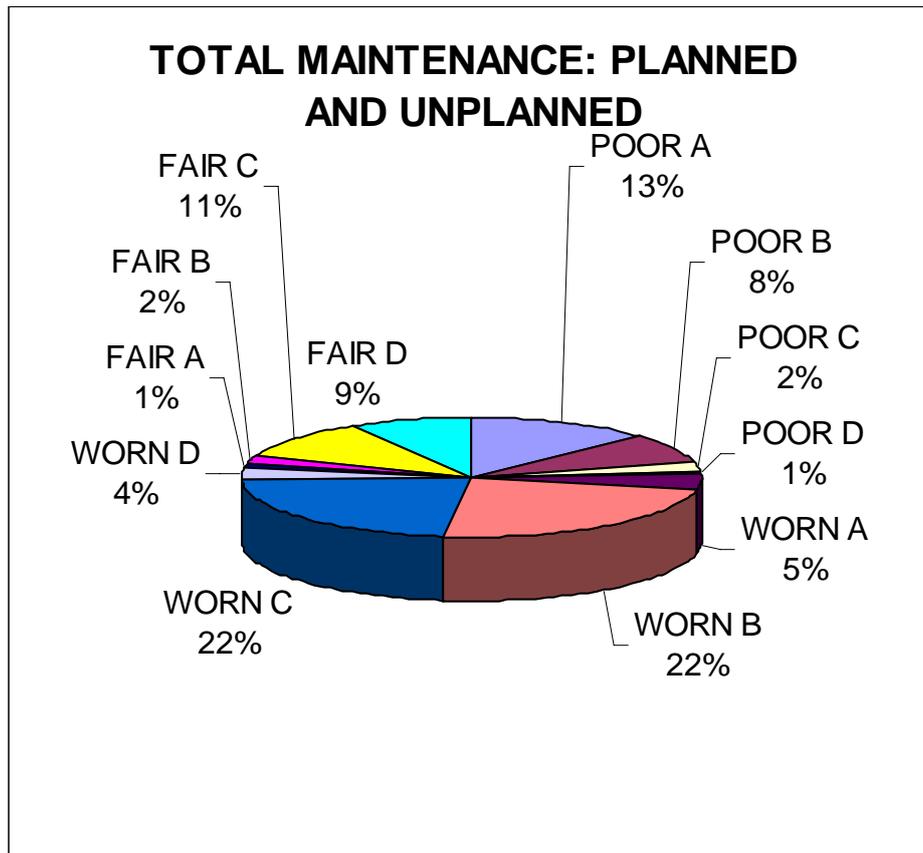
Figure 4 Planned and Unplanned Maintenance

The percentages of maintenance work in each category (planned and unplanned) of maintenance works are shown in Figure 4 below. Unfortunately, actual values of maintenance

In terms of the overall maintenance totals the categories with the highest percentages measured in the whole system (planned and unplanned) shown in Figure 4 are 'Worn B' with 22% and 'Worn C' with 22% of the total. Taken together these two categories represent nearly 50% of the total maintenance items. The next largest category is 'Poor A' with 13% and since this is the maintenance needing the most urgent attention this should and has received early funding to carry out the rectification of these items. In fact, the two highest categories of Poor A and Poor B, show over 20% of the total cost of the maintenance works requiring attention.

Interestingly, the maintenance items at the lower end of the categories, that is Worn d (4%), Fair A (1%), Fair B (2%), Fair C (11%) and Fair D (9%) amount to 27% of the total maintenance. Whilst they do not urgently require attention they show the build up of future

Note that for the purposes of audit analysis and budgetary requirements any maintenance work at Worn D category and below was automatically designated 'unplanned' as it was less critical than the maintenance items in the Poor and Worn A to C categories above this threshold. A small amount of unplanned work is also contained in the more urgent categories of Poor A, B, C and D and Worn A, B and C, but unplanned work represents a small proportion of the total work in these categories. This work is mainly to buildings that are excess to needs of the school and have been retained despite enrolment numbers falling to levels where the school can no longer justify their retention. In most cases the school would fund the maintenance in these buildings from its own sources and through the community especially where these buildings are being used by groups outside or associated with the school.

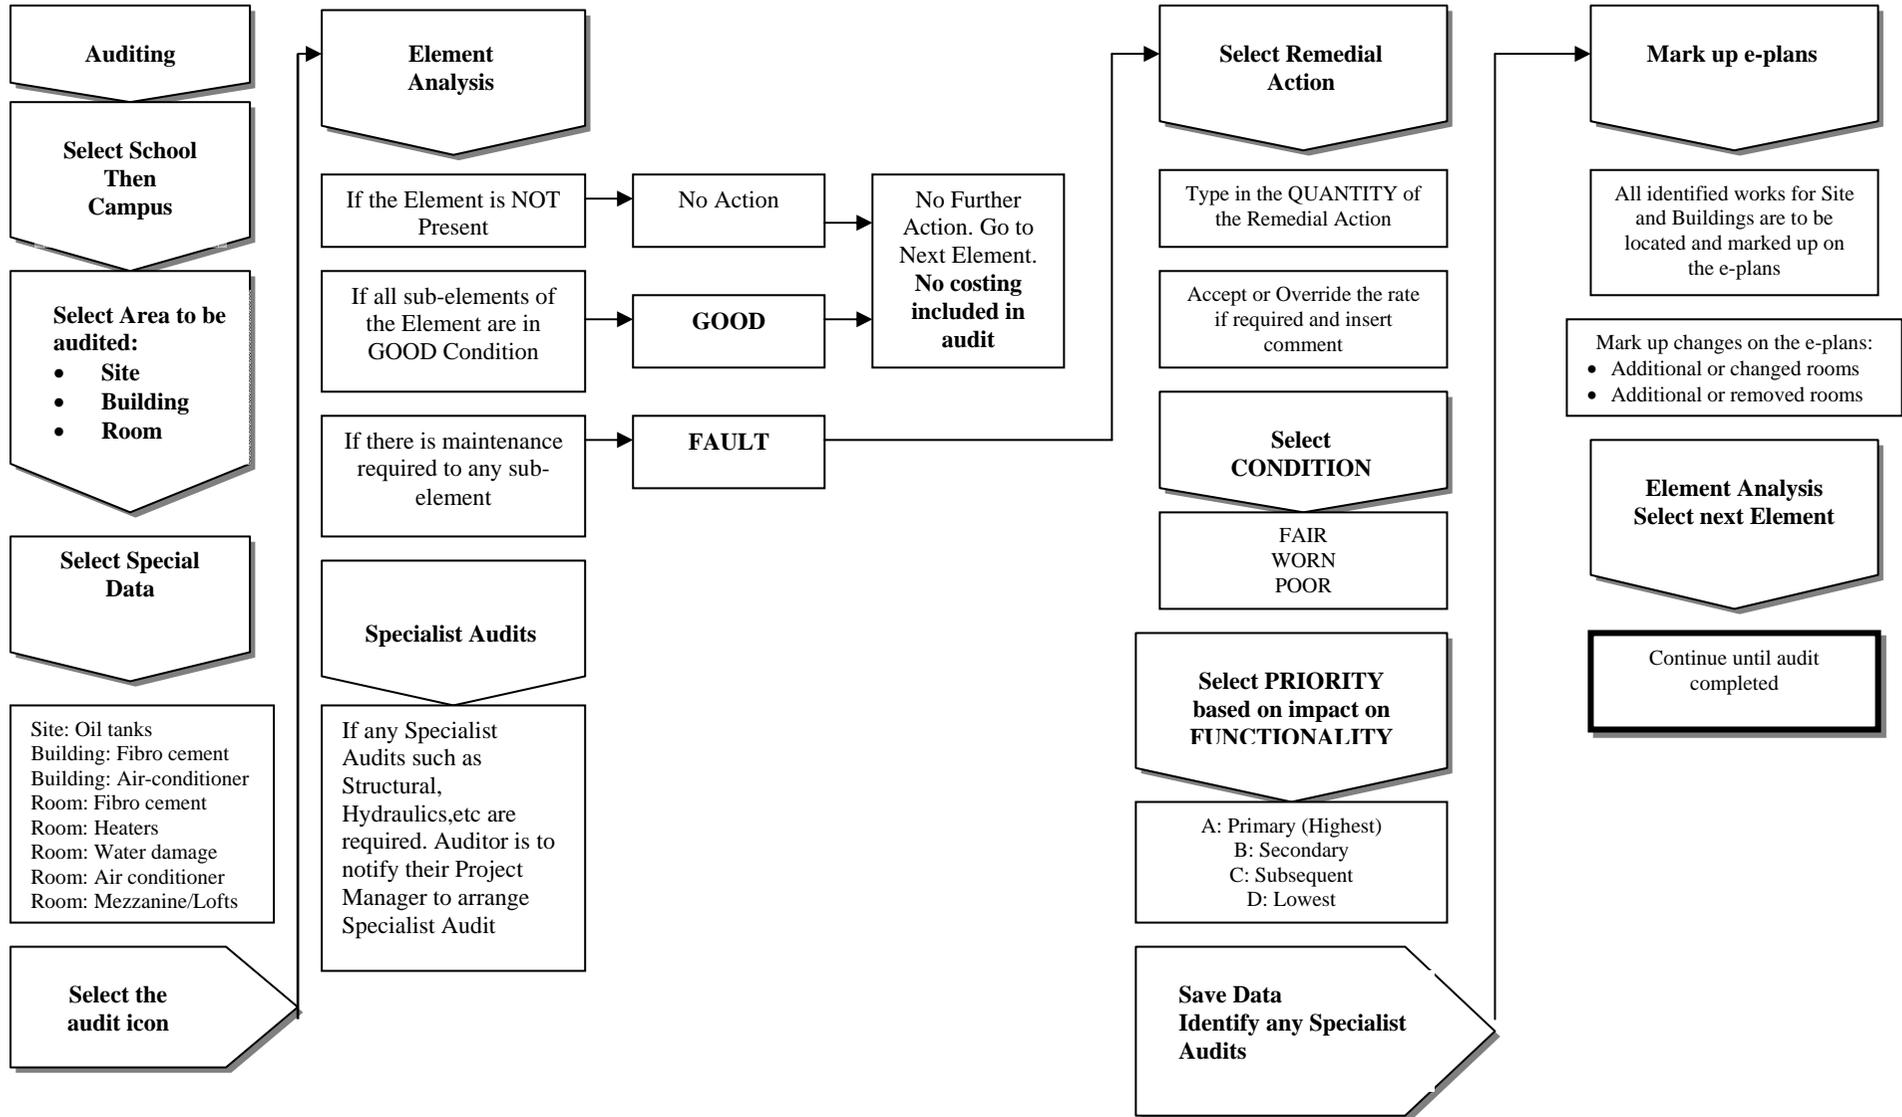
Figure 3 The Auditing Process on Site

A flow chart showing the auditing process with the on site activities is shown in Figure 3. The processes involved in the element analysis (condition assessment) and remedial action forms the central focus of these activities and the basis of these analyses are described next.

The auditor (inspector) methodically works through each element in turn for the three major groupings of *site*, *buildings* or *rooms* as noted earlier in the maintenance guidelines and shown on the first column of the flowchart in Figure 3. The auditor is guided by the *Physical Resource Management System (PRMS) Maintenance Assessment Guidelines* (DET, 2005) held on software in the hand-held computers illustrated earlier and decisions about each element's and sub-element's condition and priority are methodically recorded and automatically transmitted back to the Department for collation and analysis.

Also see the second column of the flowchart in Figure 3, which shows the steps involved in an element analysis.

For items outside the professional capabilities of the inspector and requiring a specialist report or audit from an engineer then these are entered in the audit and the project manager appointed to that area organizes this specialist audit to be completed. See column 2 of the flowchart in Figure 3.

Once the condition has been determined the auditor has to assess the priority of the remedial action to overcome the fault by identifying the impact of the chosen condition of the on the functionality or performance of the space or area. See column 5 on Figure 3.

In most situations the auditor will not override the standard costs in the system unless the auditor is confident that a rectification item identified would be *clearly outside* the standard allowance and the *cost difference would be expected to be significant*. This option is available and is shown in column 5 of Figure 3.
